# Manhole Inspection Summary

Manhole # S07WW1016MH

Insp Date: **9/12/06 7:26 AM**

**Location** Address: **5700 BLAND AVE**

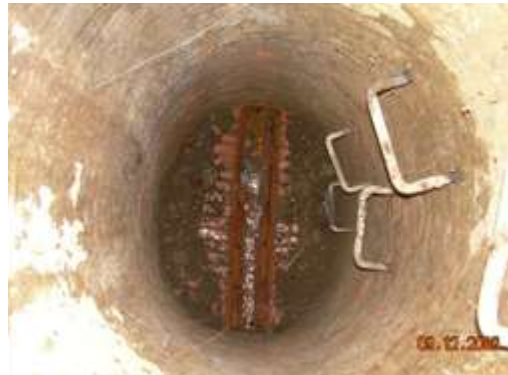
Top View

Adjustment and Corbel infiltration.  
Evidence of surcharge - Bench debris.

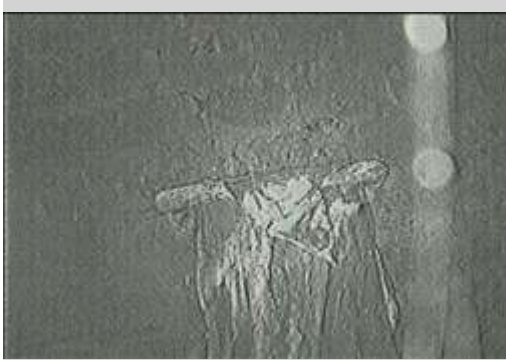
Defect

Evidence of surcharge.

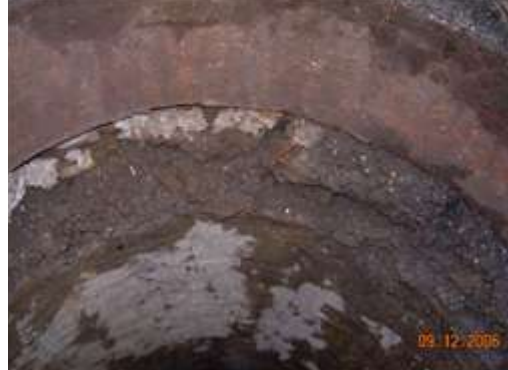
Defect

**Frame** Offset: **2** (in.) Condition: ☐ Sound ☐ Cracked ☒ **Leaks**

Condition: ☐ Sound ☐ Cracked ☐ Root Intrusion ☐ Loose Brick ☒ **Deteriorated**

Infiltration: ☐ None ☒ **Joint** ☐ Cracks ☐ Mortar ☐ Roots ☐ Wall

Frame leaks. Adjustment deterioration  
and infiltration.

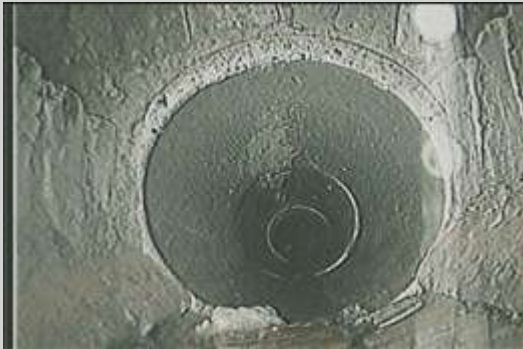
### 8 in. Circular Gravity Sewer Pipe Out @ 12 O'Clock

Deposits: ☐ None ☒ **Mud** ☐ Sludge ☒ **Debris** ☐ Grease

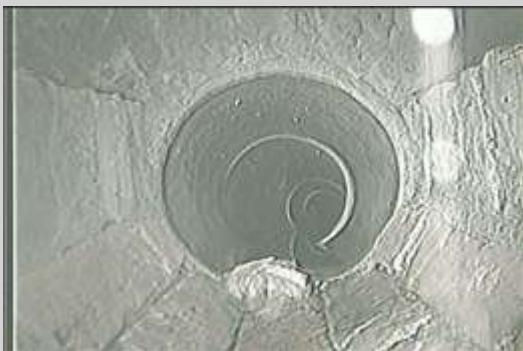
### 8 in. Circular Gravity Sewer Pipe In @ 6 O'Clock

Condition: ☐ Sound ☐ Cracked ☐ Root Intrusion ☒ **Deteriorated** ☐ Leaks ☐ Debris

Channel deterioration.
